INSPECTION REPORT

INSPECTED PROPERTY		CLIENT INFORMATION	
Address:	55__ Indian River Road, North Vancouver, B.C.	Name / Address:	
Date of Inspection:	AUGUST 15, 2010	Contact Phone #:	
Time Started:	09:30	Outdoor Temp:	17°C
Weather Conditions:	Overcast & drizzle, Mild	Outdoor Humidity:	63%
Ground Conditions:	Dry	Indoor Temp:	21°C
Those Present:	Realtor & Buyer's relative	Indoor Humidity:	45%
Occupancy:	Vacant	Referred By:	Realtor

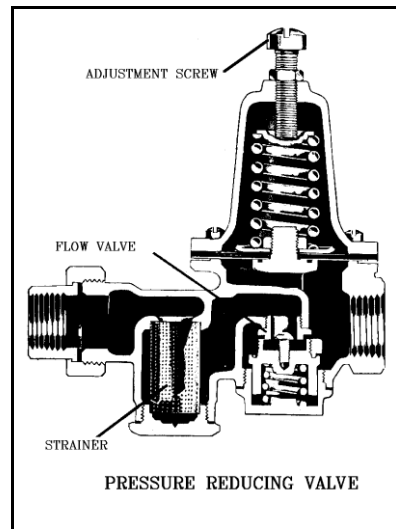
Description	Comments
Water service entry and shut off valve location:	Located at north end of main building crawl space	Leakage was observed at the main service pipe
Pressure Reducing Valve:	Standard Watts valve (see sketch below)	No problems were noted with valve
Static Water Pressure:	70 psi	Static pressure was within recommended 40 to 80 psi range
Pressure Under Flow:	60 psi @ 3 imperial gallons per minute	Pressure drop of this size is normal
Supply Piping:	Copper and plastic PEX pipe	No problems were noted with visible sections of the supply plumbing
Cross Connections:	Found at the hot water tank and hose bib	Vacuum break devices were found at these locations

Available pressures from the district water mains and local distribution systems have wide variations, depending upon elevation differences between property locations and the water distribution source. In most instances, these pressures exceed the 40 to 80 psi pressure range considered to be desirable for residential use. High water pressures can result in persistent problems with shut-off valves in appliances and other installed plumbing fixtures. Pressure reducing valves are available to allow a downward regulation. There are a number of different designs. The more common model is shown in the sketch. On the valve shown, the pressure reduction is achieved by releasing the locking nut and turning the adjusting screw. A pressure reducing valve of a similar design has been installed.

The water service pipe was found to run down the north side of the property from the parking area to the main house. The pipe was installed in a 4" diameter flexible Big O plastic pipe with insulation around the water pipe. Water running out of the lower end of the Big O pipe suggests a leakage problem in the upper section of the water pipe. A further review by a plumber and repair or replacement of this pipe is recommended.

15. Locate and repair the present leakage problem at the main water service pipe.
16. Note the advanced hot-water tank age. Budget accordingly for its near-term replacement.
